**Flood Control Project Maintenance
Levee Inspections**
LMA District Cover Sheet
Spring 2018 Levee Inspection Results

Reclamation District No. 0544 Upper Roberts Island

Spring 2018 Levee Inspection Results

Waterway			Bank	Unit Miles
Unit No. 01 San Joaquin River			Left	6.05
	Spring (March - May)	Summer (June - August)	(September - November) Fall	Winter (December - February)
Unit Maintenance Rating (Fall Only)				
Date of Inspection	4/26/2018 - 4/26/2018			
DWR Inspector	Richard Willoughby			
Accompanied By	Richard Toy KSN

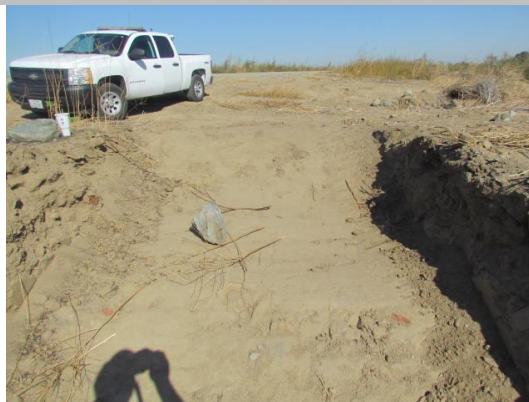
Photo 1 of 4 : SP_2018_RD0544_108_121_20180323_00093.jpg

LM Start	5.60	Rating **	U	Issue No.	121
LM End	5.60	Issue Type +	Ma	Location *	WS
Category	Earthen Levee		GPS Latitude/Longitude		
			Start	End	
Item	Erosion / Bank Caving		37.811234 °	37.811234 °	
			-121.321412 °	-121.321412 °	
DWR ID	DWR_RD0544_01_f_2015_121				
Comment Code					
E2 : Schedule repair of erosion site prior to the next inspection.					
Inspector Comment					
Someone digging/excavating on waterward berm. Excavation in 3ft wide and eighteen inches deep and ten feet long.

Looking west at excavation on waterward berm.

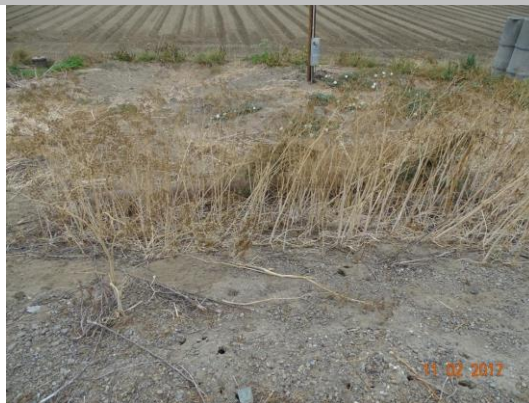
Photo 1 of 1 : SP_2018_RD0544_108_110_20180323_00080.jpg

LM Start	5.72	Rating **	M	Issue No.	110
LM End	5.72	Issue Type +	En	Location *	LS
Category	Earthen Levee			GPS Latitude/Longitude	
				Start	End
Item	Encroachments			37.811205 °	37.811205 °
				-121.323606 °	-121.323606 °
DWR ID	DWR_RD0544_01_f_2017_110				
Comment Code					
PI : Pipe					
Inspector Comment					
Discarded pipe at toe of landside slope.

Looking north at the landside slope.

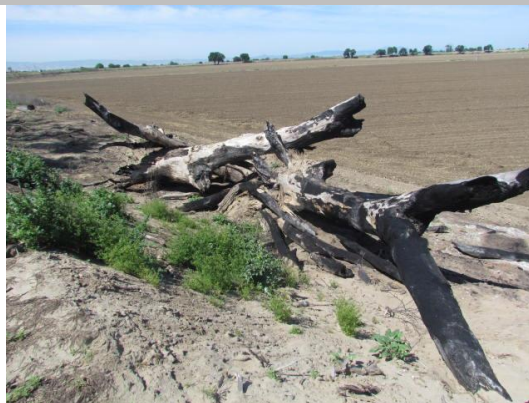
Photo 1 of 2 : SP_2018_RD0544_108_124_20180323_00100.jpg

LM Start	5.82	Rating **	A/W	Issue No.	124
LM End	5.82	Issue Type +	Ma	Location *	LS
Category	Earthen Levee			GPS Latitude/Longitude	
				Start	End
Item	Encroachments			37.811049 °	37.811049 °
				-121.325451 °	-121.325451 °
DWR ID	DWR_RD0544_01_s_2016_124				
Comment Code					
TR : Tree or limb					
Inspector Comment

Looking east at tree limbs on waterward slope.

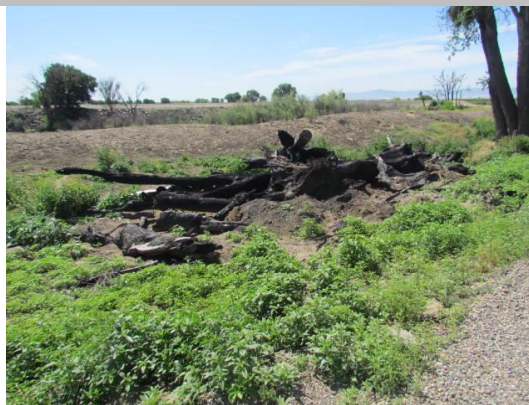
Photo 2 of 2 : SP_2018_RD0544_108_124_20180323_00101.jpg

LM Start	5.82	Rating **	A/W	Issue No.	124 (cont)
LM End	5.82	Issue Type +	Ma	Location *	LS

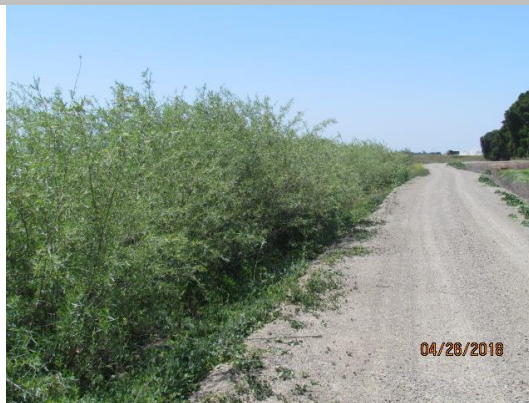
Photo 1 of 1 : SP_2018_RD0544_109_2_20180427_00130.jpg

LM Start	0.21	Rating **	U	Issue No.	2
LM End	0.26	Issue Type +	Ma	Location *	WS
Category	Earthen Levee			GPS Latitude/Longitude	
				Start	End
Item	Vegetation			37.808331 °	37.808576 °
				-121.331997 °	-121.332672 °
DWR ID	DWR_RD0544_02_s_2018_2				
Comment Code					
V2 : Remove the wild growth other than native grasses from the levee slopes.					
Inspector Comment

Looking southeast at dense veg on waterward slope. (Spring 2018)

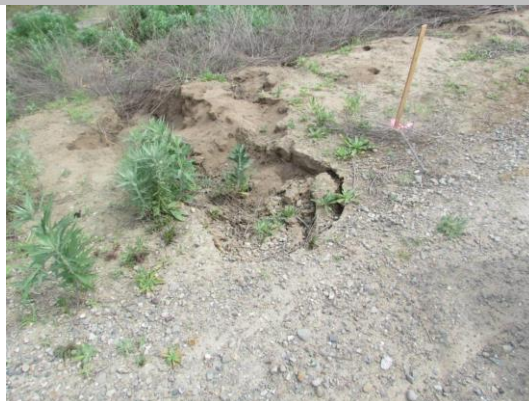
Photo 1 of 1 : SP_2018_RD0544_109_71_20180323_00060.jpg

LM Start	0.44	Rating **	U	Issue No.	71
LM End	0.44	Issue Type +	Ma	Location *	LS
Category	Earthen Levee			GPS Latitude/Longitude	
				Start	End
Item	Erosion / Bank Caving			37.810388 °	37.810388 °
				-121.334977 °	-121.334977 °
DWR ID	DWR_RD0544_02_s_2017_71				
Comment Code					
Inspector Comment					
Landside erosion due to runoff.

Looking northwest at runoff erosion on landward shoulder and slope.

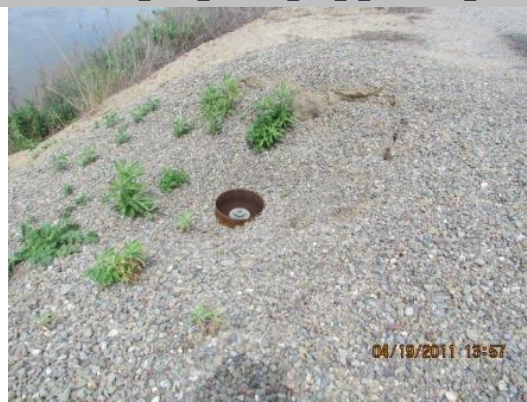
Photo 1 of 4 : SP_2018_RD0544_109_8_20180323_00010.jpg

LM Start	0.78	Rating **	U	Issue No.	8
LM End	0.78	Issue Type +	Ma	Location *	WS
Category	Interior Drainage & Piping Systems			GPS Latitude/Longitude	
				Start	End
Item	Erosion Areas			37.815094 °	37.815094 °
				-121.333927 °	-121.333927 °
DWR ID	DWR_RD0544_02_s_2012_8				
Comment Code					
Inspector Comment					
Caving under and around siphon on waterside shoulder. No material 3' below pipe. Caving around siphon is 20" to 24" deep approximately 72" in diameter. During 2012 spring inspection hole appears to be enlarging.

Looking south at depression greater than 6" on waterside shoulder.

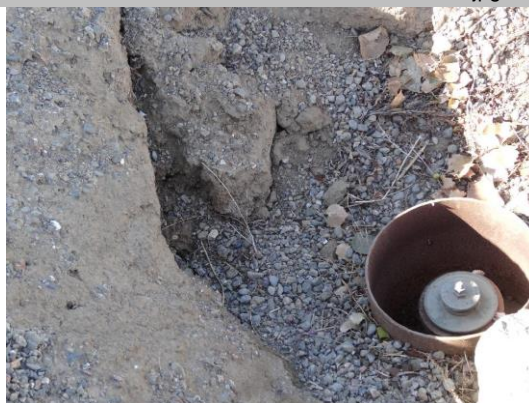
Photo 2 of 3 : UCIP_SP_2018_51382_44881.jpg

WS view: depression on levee slope around siphon breaker. Siphon breaker in steel pipe riser.

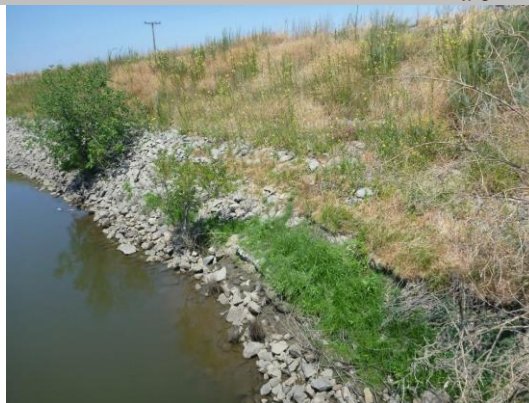
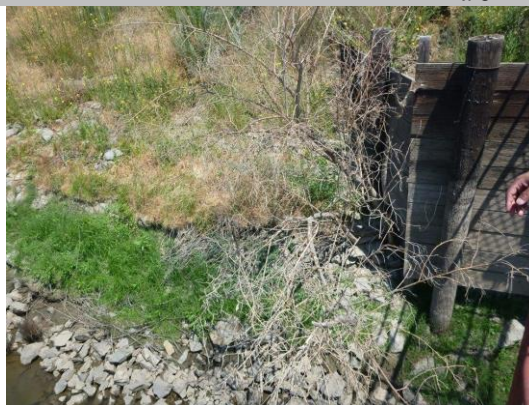
Description: Slope protection repairs are needed along the waterside slope due to erosion and riprap displacement from high water. Based upon levee inspections, it was determined the waterside levee slope is eroding, deteriorating, and degrading. The eroded levee sections need to be restored back to design standards to prevent further deterioration and damage.

LM Start	1.01	Rating **	A/W	Issue No.	82 (cont)
LM End	1.02	Issue Type +	Ma	Location *	
Category	Supplemental			GPS Latitude/Longitude	
				Start	End
Item	2017 Storm Damage			37.818100 °	37.818200 °
				-121.332800 °	-121.332800 °
DWR ID	DWR_RD0544_02_f_2017_82				
Comment Code					
Inspector Comment					
Levee Evaluation Comments					
Description:Slope protection repairs are needed along the waterside slope due to erosion and riprap displacement from high water. Based upon levee inspections, it was determined the waterside levee slope is eroding, deteriorating, and degrading. The eroded levee sections need to be restored back to design standards to prevent further deterioration and damage.					
Site ID No:552					
Site Designation:LMA-458					
Repair Type: Erosion					
Rating:Area of Concern					
Field Date:8/16/2017					
Notes:

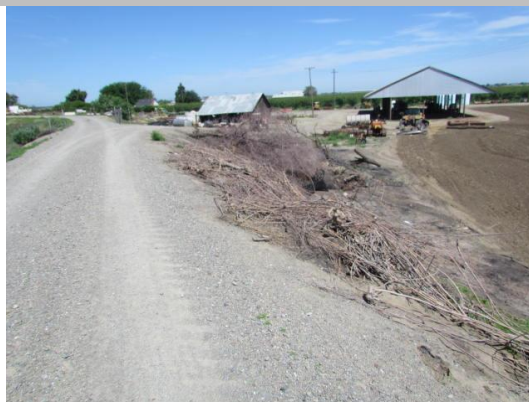
Photo 1 of 1 : SP_2018_RD0544_109_20_20180323_00024.jpg

LM Start	1.12	Rating **	A/W	Issue No.	20
LM End	1.12	Issue Type +	En	Location *	LS
Category	Earthen Levee			GPS Latitude/Longitude	
				Start	End
Item	Encroachments			37.819530 °	37.819530 °
				-121.333827 °	-121.333827 °
DWR ID	DWR_RD0544_02_s_2012_20				
Comment Code					
PR : Prunings					
Inspector Comment					
Landowner is stock piling prunings on landside slope and toe.

Looking southwest at pruning piles on landward slope.

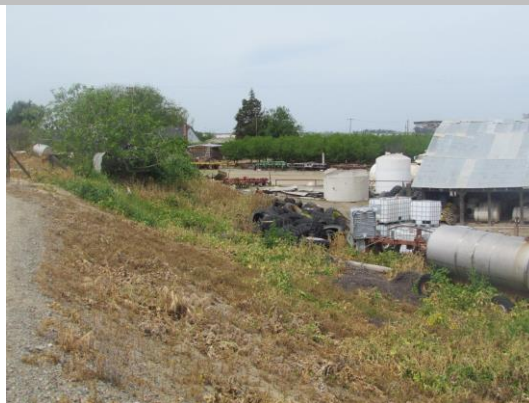
Photo 1 of 2 : SP_2018_RD0544_109_25_20180323_00028.jpg

LM Start	1.13	Rating **	U	Issue No.	25
LM End	1.19	Issue Type +	En	Location *	LS
Category	Earthen Levee			GPS Latitude/Longitude	
				Start	End
Item	Encroachments			37.819560 °	37.820083 °
				-121.333893 °	-121.334812 °
DWR ID	DWR_RD0544_02_s_2012_25				
Comment Code					
DE : Debris					
Inspector Comment

Looking south at farm equipment stored on landward shoulder and slope.

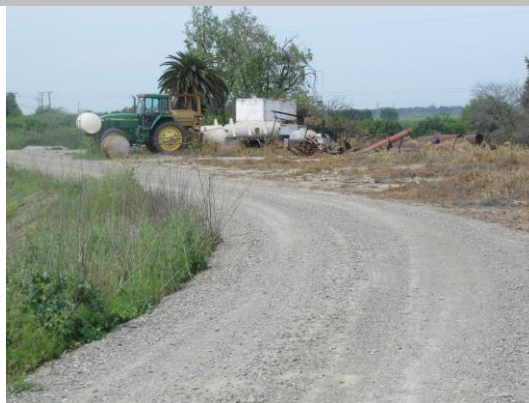
Photo 2 of 2 : SP_2018_RD0544_109_25_20180323_00029.jpg

LM Start	1.13	Rating **	U	Issue No.	25 (cont)
LM End	1.19	Issue Type +	En	Location *	LS

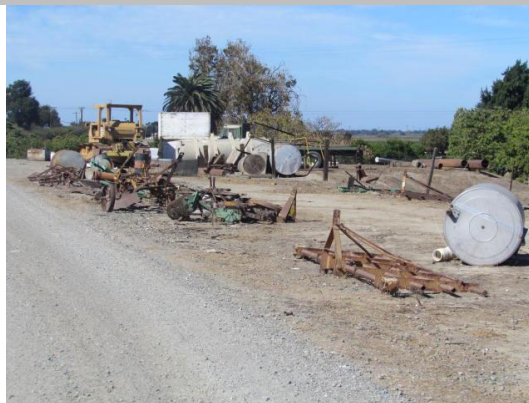
Photo 2 of 4 : SP_2018_RD0544_109_18_20180323_00021.jpg

Looking southwest at equipment stored on landward shoulder. (spring 2015)

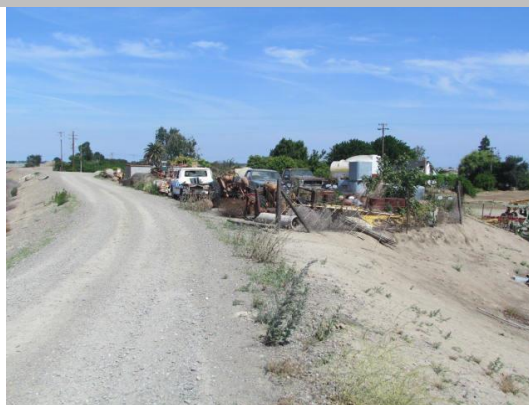
Photo 3 of 4 : SP_2018_RD0544_109_18_20180323_00022.jpg

Looking southwest at vehicles and farm equipment stored on landside landing. (spring 2014)

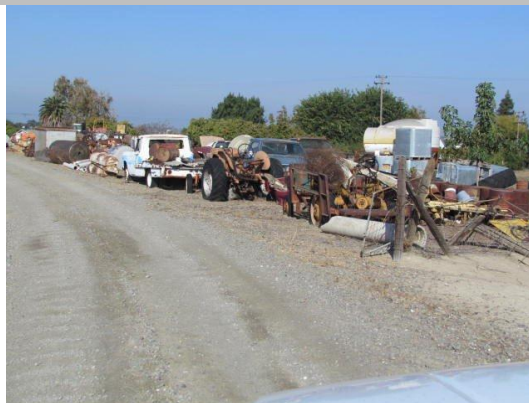
Photo 4 of 4 : SP_2018_RD0544_109_18_20180323_00023.jpg

Looking southwest at farm equipment, vehicles, and other items stored on landside landing. (spring 2013)

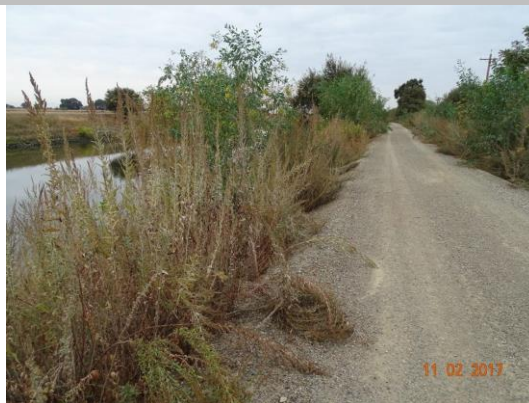
Photo 1 of 1 : SP_2018_RD0544_109_101_20180323_00098.jpg

LM Start	1.29	Rating **	U	Issue No.	101
LM End	1.56	Issue Type +	Ma	Location *	WS
Category	Earthen Levee			GPS Latitude/Longitude	
				Start	End
Item	Vegetation			37.820668 °	37.822239 °
				-121.336491 °	-121.340589 °
DWR ID	DWR_RD0544_02_f_2017_101				
Comment Code					
V2 : Remove the wild growth other than native grasses from the levee slopes.					
Inspector Comment

Looking northwest at the waterside slope.

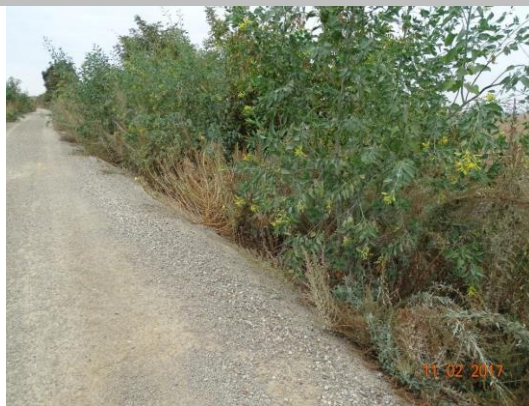
Photo 1 of 1 : SP_2018_RD0544_109_102_20180323_00099.jpg

LM Start	1.29	Rating **	U	Issue No.	102
LM End	1.56	Issue Type +	Ma	Location *	LS
Category	Earthen Levee			GPS Latitude/Longitude	
				Start	End
Item	Vegetation			37.820668 °	37.822239 °
				-121.336491 °	-121.340589 °
DWR ID	DWR_RD0544_02_f_2017_102				
Comment Code					
V2 : Remove the wild growth other than native grasses from the levee slopes.					
Inspector Comment

Looking northwest at the landside slope.

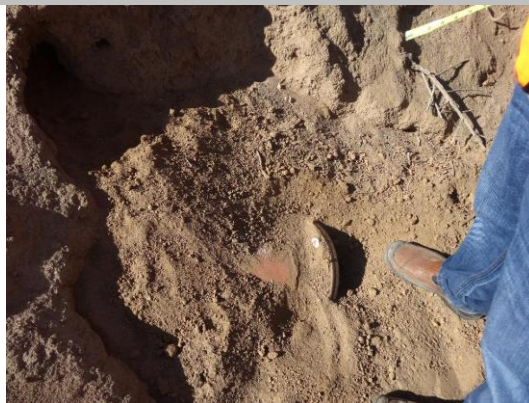
Photo 2 of 3 : UCIP_SP_2018_46674_44889.jpg

LS view: steel pipe on levee slope with opened end. Levee slope erosion around the pipe.

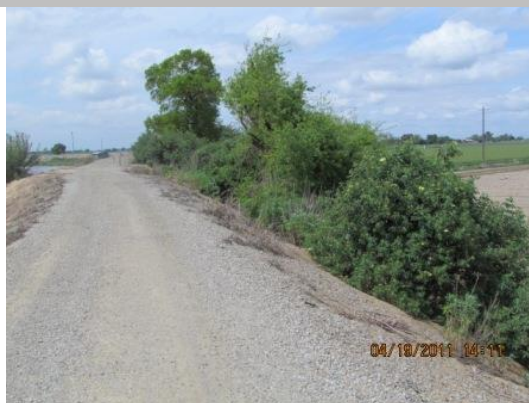
Photo 1 of 2 : SP_2018_RD0544_109_10_20180323_00014.jpg

LM Start	1.38	Rating **	U	Issue No.	10
LM End	1.38	Issue Type +	Ma	Location *	LS
Category	Earthen Levee			GPS Latitude/Longitude	
				Start	End
Item	Vegetation			37.821423 °	37.821423 °
				-121.337878 °	-121.337878 °
DWR ID	DWR_RD0544_02_s_2012_10				
Comment Code					
V4 : Elderberries are blocking visibility and flood fight capability.					
Inspector Comment					
Dense elderberry on landside slope and toe.

Looking southwest at elderberries on landside slope.

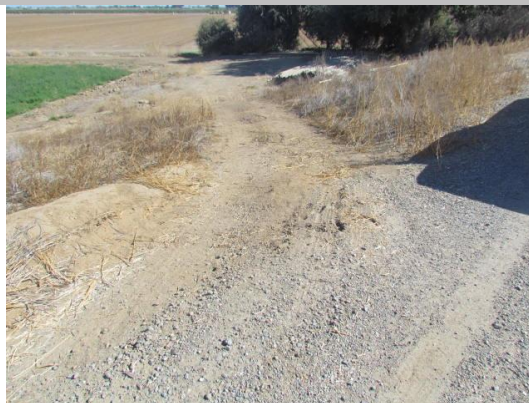
Photo 1 of 2 : SP_2018_RD0544_109_22_20180323_00025.jpg

LM Start	1.40	Rating **	M	Issue No.	22
LM End	1.42	Issue Type +	Ma	Location *	LS
Category	Earthen Levee			GPS Latitude/Longitude	
				Start	End
Item	Slope Stability			37.821518 °	37.821697 °
				-121.338092 °	-121.338397 °
DWR ID	DWR_RD0544_02_s_2012_22				
Comment Code					
S3 : Repair the levee slope damaged by vehicle traffic and prevent access where possible.					
Inspector Comment					
Damage caused by vehicle traffic.

Looking northwest at slope damage caused by vehicle traffic (Fall 2014).

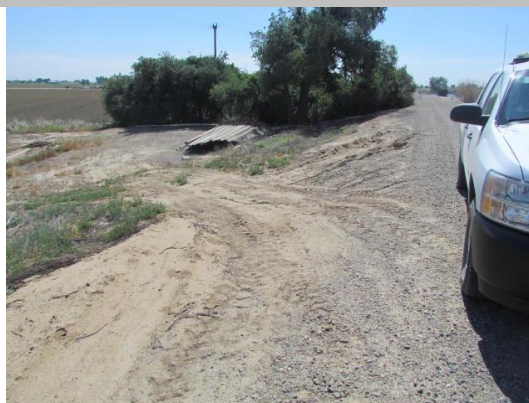
Photo 2 of 2 : SP_2018_RD0544_109_22_20180323_00026.jpg

Looking northwest at slope damage caused by vehicle traffic.

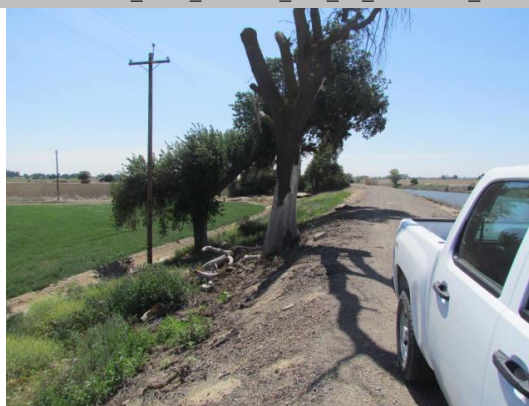
Photo 1 of 1 : SP_2018_RD0544_109_23_20180323_00027.jpg

LM Start	1.46	Rating **	A/W	Issue No.	23
LM End	1.46	Issue Type +	Ma	Location *	LS
Category	Earthen Levee			GPS Latitude/Longitude	
				Start	End
Item	Encroachments			37.822082 °	37.822082 °
				-121.338932 °	-121.338932 °
DWR ID	DWR_RD0544_02_s_2012_23				
Comment Code					
TR : Tree or limb					
Inspector Comment					
Dead tree and limbs should be removed from landside shoulder and slope.

Looking north at dead tree and tree limbs on landside shoulder and slope.

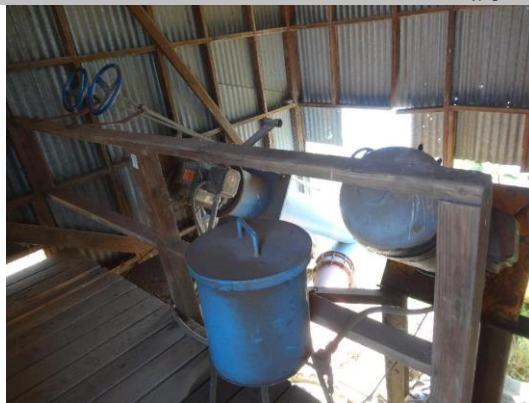
Photo 2 of 3 : UCIP_SP_2018_24288_42946.jpg

Comment Code						
Inspector Comment						
FS_ID:24288						
DS_ID:22669						
EP_NO: N/A						
Repair Type: Non-Urgent						
Crossing Status: Found						
UCIP Comments: - two pumps with 16" steel pipe and an abandoned pump with 10" pipe inside pump house.- CMP riser cover needs repair. - electric conduits on waterside and power pole on landside.						
FIELD_STRUCT_DESC: 24-inch steel irrigation discharge pipe through the levee, 14 feet below the crown. Pump in a pump house on the waterside (WS) berm. Slide gate in a corrugated metal pipe (CMP) riser on the WS slope. Two corrugated metal cutoff walls. Distribution box and power pole at the landside (LS) toe. [Additional Reference(s): DWR Levee Log, 2005. USACE San Joaquin O&M Manual 7, April 1964, (HLM 1.53)].						
FS Date: 10/31/2013

WS view: two pumps discharges water into CMP riser on levee slope.

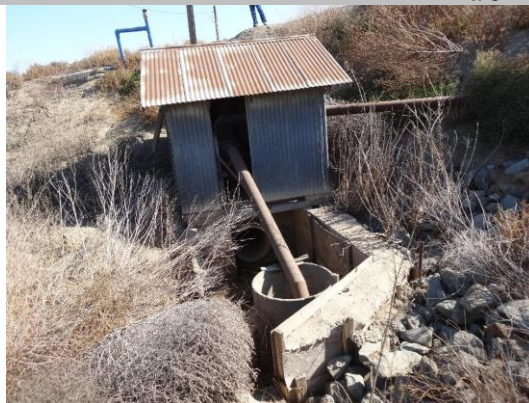
Photo 1 of 3 : UCIP_SP_2018_24907_44895.jpg

LM Start	1.52	Rating **	M	Issue No.	106	
LM End	1.52	Issue Type +	En	Location *		
Category	Supplemental			GPS Latitude/Longitude		
				Start		End
Item	DWR UCIP Field Study			37.822445 °		37.822445 °
				-121.339910 °		-121.339910 °
DWR ID						
Comment Code						
Inspector Comment						
FS_ID:24907						
DS_ID:24716						
EP_NO: N/A						
Repair Type: Non-Urgent						
Crossing Status: Found						
UCIP Comments: No pipe and appurtenances found on waterside.Looks abandoned.						
FIELD_STRUCT_DESC: *ABANDONED* 8-inch steel drainage						
discharge pipe through the levee, at an unknown depth. Pump house at						
the landside (LS) toe. Air vent in a corrugated metal pipe (CMP) riser on						
the LS shoulder. Outlet on the waterside (WS) not visible. No positive						
closure device. Appears abandoned.						
FS Date: 10/31/2013

LS view: pipe, pump house, and appurtenances on levee slope.

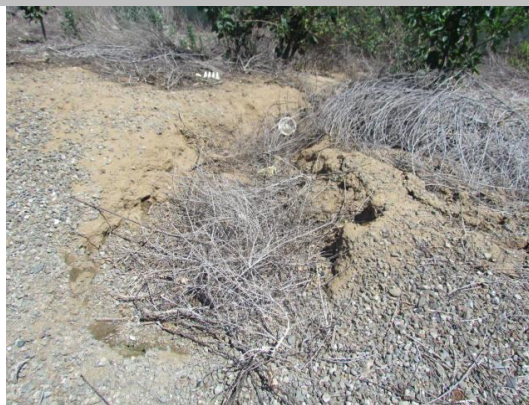
Photo 2 of 2 : SP_2018_RD0544_109_38_20180323_00037.jpg

Looking east at erosion/caving on waterward slope.

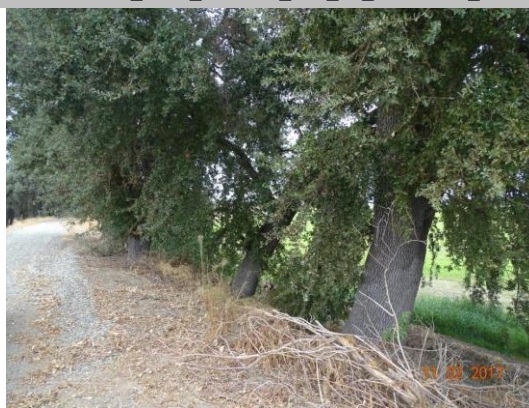
Photo 1 of 2 : SP_2018_RD0544_109_59_20180323_00047.jpg

LM Start	2.12	Rating **	A/W	Issue No.	59
LM End	2.12	Issue Type +	Ma	Location *	LS
Category	Earthen Levee			GPS Latitude/Longitude	
				Start	End
Item	Trim / Thin Trees			37.819738 °	37.819738 °
				-121.344922 °	-121.344922 °
DWR ID	DWR_RD0544_02_s_2015_59				
Comment Code					
T1 : Trim trees to at least five feet above ground level.					
Inspector Comment					
Untrimmed trees on landside shoulder and slope.

Looking northwest at the landside slope.

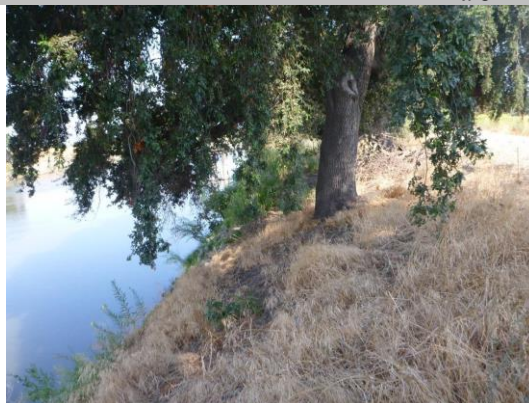
LM Start	2.17	Rating **	A/W	Issue No.	87
LM End	2.18	Issue Type +	Ma	Location *	
Category	Supplemental		GPS Latitude/Longitude		
			Start	End	
Item	2017 Storm Damage		37.820300 °	37.820300 °	
			-121.345600 °	-121.345700 °	
DWR ID	DWR_RD0544_02_f_2017_87				
Comment Code					
Inspector Comment					
<p>Levee Evaluation Comments</p> <p>Description: Slope protection repairs are needed along the waterside slope due to erosion and riprap displacement from high water. Based upon levee inspections, it was determined the waterside levee slope is eroding, deteriorating, and degrading. The eroded levee sections need to be restored back to design standards to prevent further deterioration and damage.</p> <p>Site ID No: 551</p> <p>Site Designation: LMA-457</p> <p>Repair Type: Erosion</p> <p>Rating: Serious</p> <p>Field Date: 8/18/2017</p> <p>Notes:</p>

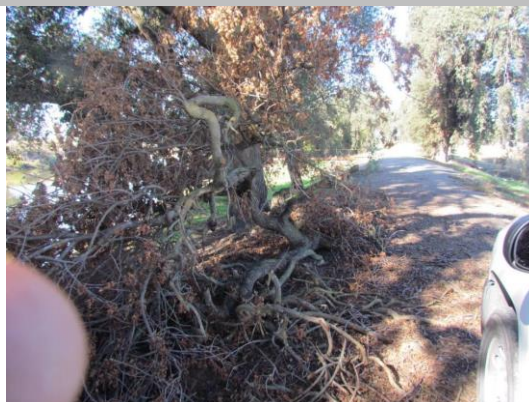
Photo 1 of 1 : SP_2018_RD0544_109_68_20180323_00053.jpg

LM Start	2.18	Rating **	A/W	Issue No.	68
LM End	2.18	Issue Type +	En	Location *	WS
Category	Earthen Levee			GPS Latitude/Longitude	
				Start	End
Item	Encroachments			37.820315 °	37.820315 °
				-121.345689 °	-121.345689 °
DWR ID	DWR_RD0544_02_f_2016_68				
Comment Code					
TR : Tree or limb					
Inspector Comment					
Broken dead tree limb on waterside shoulder.

Looking at broken tree branch on waterward shoulder.

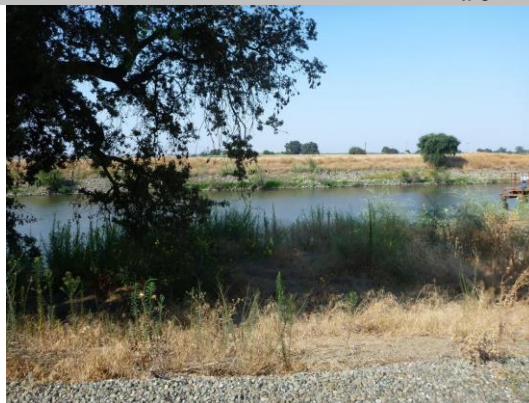
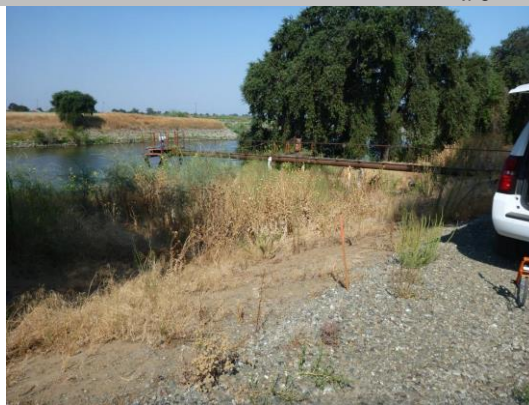
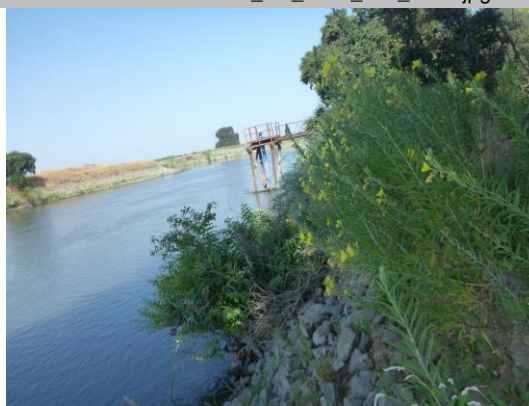
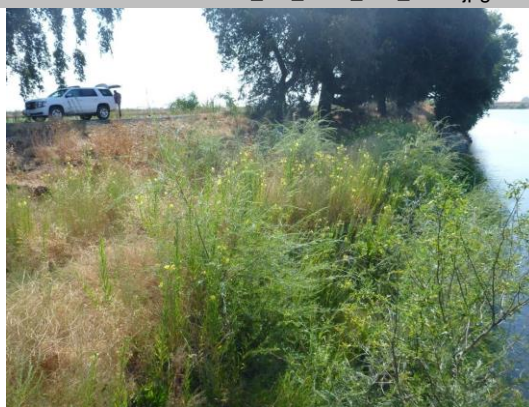
LM Start	2.18	Rating **	A/W	Issue No.	88
LM End	2.19	Issue Type +	Ma	Location *	
Category	Supplemental			GPS Latitude/Longitude	
				Start	End
Item	2017 Storm Damage			37.820400 °	37.820500 °
				-121.345800 °	-121.345900 °
DWR ID	DWR_RD0544_02_f_2017_88				
Comment Code					
Inspector Comment					
Levee Evaluation Comments					
Description:Slope protection repairs are needed along the waterside slope due to erosion and riprap displacement from high water. Based upon levee inspections, it was determined the waterside levee slope is eroding, deteriorating, and degrading. The eroded levee sections need to be restored back to design standards to prevent further deterioration and damage.					
Site ID No:550					
Site Designation:LMA-456					
Repair Type: Erosion					
Rating:Area of Concern					
Field Date:8/18/2017					
Notes:

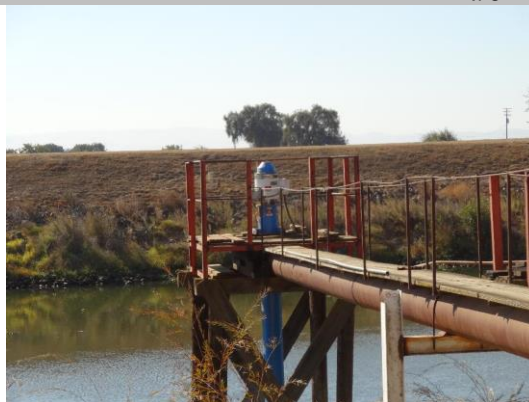
Photo 2 of 3 : UCIP_SP_2018_41731_42953.jpg

WS view: closer view of pipe, walkway, and pump on pile structure.

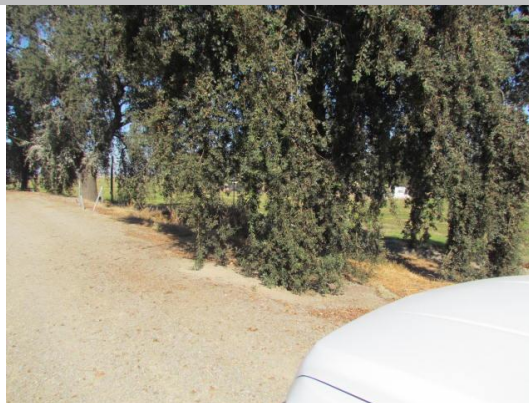
Photo 1 of 1 : SP_2018_RD0544_109_61_20180323_00049.jpg

LM Start	2.28	Rating **	A/W	Issue No.	61
LM End	2.28	Issue Type +	Ma	Location *	LS
Category	Earthen Levee			GPS Latitude/Longitude	
				Start	End
Item	Trim / Thin Trees			37.821473 °	37.821473 °
				-121.346860 °	-121.346860 °
DWR ID	DWR_RD0544_02_s_2015_61				
Comment Code					
T1 : Trim trees to at least five feet above ground level.					
Inspector Comment					
Untrimmed tree on landside shoulder. Tree was trimmed but still requires additional trimming.

Looking west at untrimmed trees on landward slope fall 2015.

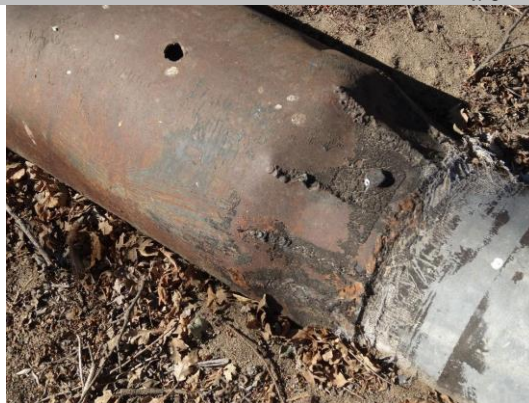
Photo 2 of 3 : UCIP_SP_2018_24293_42964.jpg

LM Start	2.29	Rating **	M	Issue No.	108 (cont)	
LM End	2.29	Issue Type +	En	Location *		
Category	Supplemental			GPS Latitude/Longitude		
				Start	End	
Item	DWR UCIP Field Study			37.821628 °	37.821628 °	
				-121.347016 °	-121.347016 °	
DWR ID						
Comment Code						
Inspector Comment						
FS_ID:24293						
DS_ID:22676						
EP_NO: N/A						
Repair Type: Non-Urgent						
Crossing Status: Found						
UCIP Comments: Pump not found on the landward side.						
FIELD_STRUCT_DESC: 10-inch steel drainage discharge pipe through the levee, 3 feet below the crown. Pump on the landside (LS). No flap gate on the waterside (WS) end. Air vent on the LS. [Additional Reference(s): DWR Levee Log, 2005. USACE San Joaquin O&M Manual 7, April 1964, (HLM 2.33)].						
FS Date: 10/31/2013

WS view: 12" steel pipe connected to 10" pipe. Holes on pipe top found.

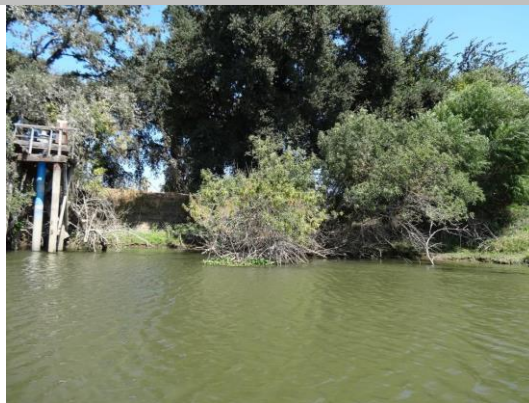
Photo 1 of 3 : SP_2018_RD0544_109_11_20180323_00016.jpg

LM Start	2.31	Rating **	M	Issue No.	11
LM End	2.31	Issue Type +	Ma	Location *	WS
Category	Supplemental			GPS Latitude/Longitude	
				Start	End
Item	DWR Erosion Survey			37.821763 °	37.821763 °
				-121.347275 °	-121.347275 °
DWR ID	RD0544U02RM33.21				
Comment Code					
Inspector Comment					
09/13/2017: No significant change observed. 07/25/2016: No significant change observed. 06/25/2015: No significant change observed. 07/02/2014: No significant change observed. 08/20/2013: No significant change observed. 08/07/2012: The site was first reported in 2012 spring levee inspection report. The data were estimated as the site is underneath a irrigation pump station and inaccessible by boat or land survey. It's possible the pump station played a role in the erosion. [2017 Site ID:RD0544U02RM33.21]

Front view of the erosion site. View is partially blocked by the pump structure and vegetation at the site.

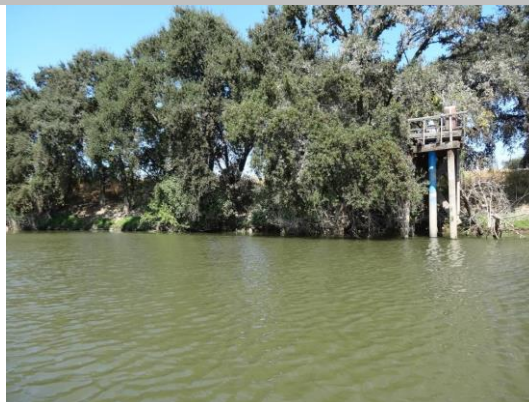
Photo 2 of 3 : SP_2018_RD0544_109_11_20180323_00017.jpg

Front view of the site.

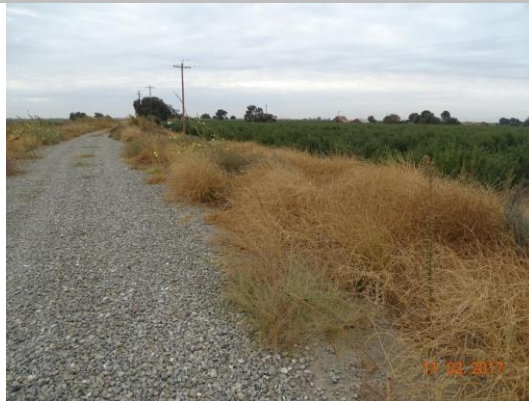
Photo 1 of 1 : SP_2018_RD0544_109_73_20180323_00061.jpg

LM Start	2.48	Rating **	U	Issue No.	73
LM End	2.59	Issue Type +	Ma	Location *	LS
Category	Earthen Levee			GPS Latitude/Longitude	
				Start	End
Item	Vegetation			37.820477 °	37.819153 °
				-121.349345 °	-121.350231 °
DWR ID	DWR_RD0544_02_f_2017_73				
Comment Code					
V2 : Remove the wild growth other than native grasses from the levee slopes.					
Inspector Comment

Looking southwest at the landside slope.

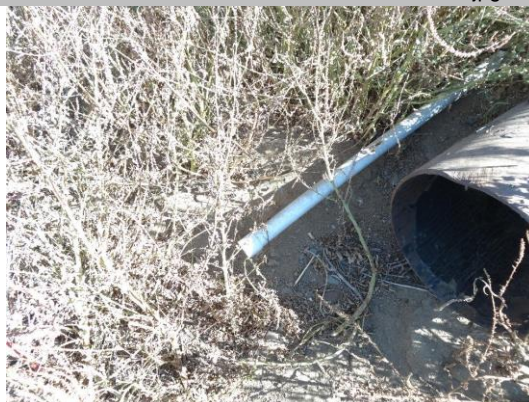
Photo 2 of 3 : UCIP_SP_2018_51380_42976.jpg

LS view: steel pipe and electric conduit on levee shoulder.

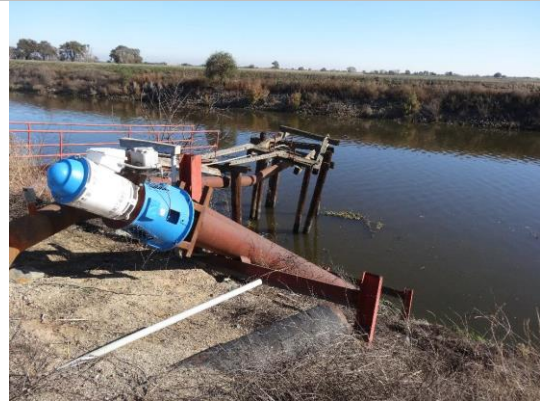
Photo 3 of 3 : UCIP_SP_2018_51380_76632.jpg

LM Start	2.61	Rating **	U	Issue No.	110 (cont)	
LM End	2.61	Issue Type +	En	Location *		
Category	Supplemental			GPS Latitude/Longitude		
				Start	End	
Item	DWR UCIP Field Study			37.818860 °	37.818860 °	
				-121.350428 °	-121.350428 °	
DWR ID						
Comment Code						
Inspector Comment						
FS_ID:51380 DS_ID:24718 EP_NO: N/A Repair Type: Urgent Crossing Status: Found UCIP Comments: 12/22/2016: Pipe is open on both ends and requires either proper abandonment or flap gate and closure device. Crossing has been upgraded from Non-Urgent to Urgent. (K. Fazel - UCIP)10/31/2013:- needs proper abandonment or closer of pipe end. (P. Amatya - DWR) FIELD_STRUCT_DESC: 14-inch steel pipe of an unknown purpose through the levee, 2 feet below the crown. Pipe open on both ends. 1-inch open conduit also at this location. This crossing was field discovered. FS Date: 12/22/2016

WS view

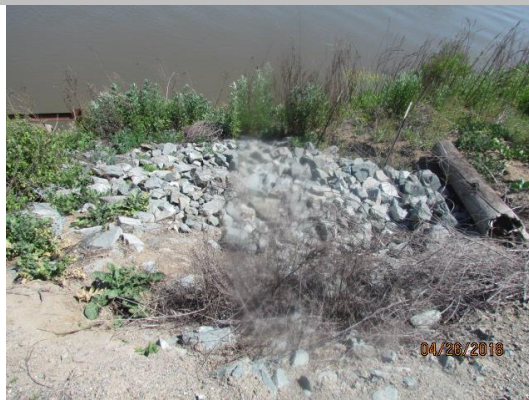
Photo 2 of 5 : SP_2018_RD0544_109_69_20180427_00133.jpg

LM Start	2.61	Rating **	U	Issue No.	69 (cont)	
LM End	2.61	Issue Type +	Ma	Location *	WS	
Category	Earthen Levee			GPS Latitude/Longitude		
				Start	End	
Item	Erosion / Bank Caving			37.818806 °	37.818806 °	
				-121.350437 °	-121.350437 °	
DWR ID	DWR_RD0544_02_f_2016_69					
Comment Code						
E2 : Schedule repair of erosion site prior to the next inspection.						
Inspector Comment						
Erosion greater than 1' deep and greater than 3' wide. Owner backfilled erosion with rock 3/4 filled. Still need to backfill the remaining erosion.

Looking east at erosion on waterward slope. (Spring 2018)

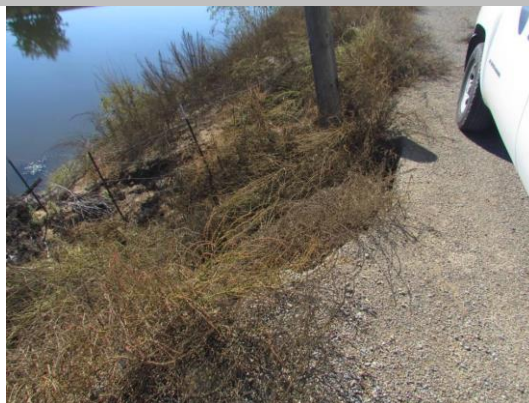
Photo 3 of 5 : SP_2018_RD0544_109_69_20180323_00054.jpg

Looking south at erosion on waterward shoulder and slope.

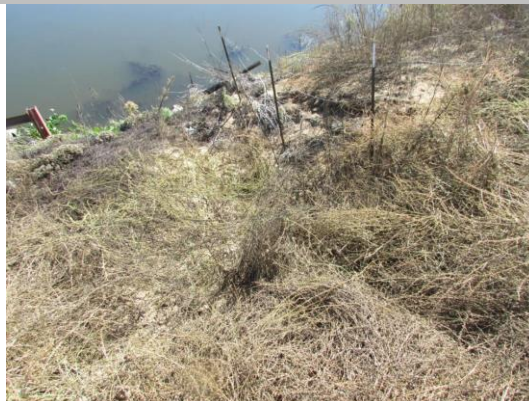
Photo 4 of 5 : SP_2018_RD0544_109_69_20180323_00056.jpg

Looking south at waterward erosion.

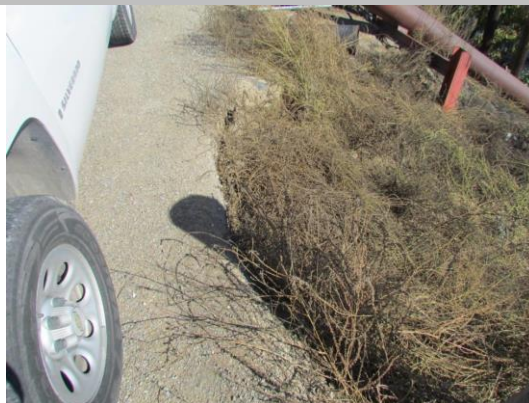
Photo 5 of 5 : SP_2018_RD0544_109_69_20180323_00055.jpg

LM Start	2.61	Rating **	U	Issue No.	69 (cont)	
LM End	2.61	Issue Type +	Ma	Location *	WS	
Category	Earthen Levee			GPS Latitude/Longitude		
				Start		End
Item	Erosion / Bank Caving			37.818806 °		37.818806 °
				-121.350437 °		-121.350437 °
DWR ID	DWR_RD0544_02_f_2016_69					
Comment Code						
E2 : Schedule repair of erosion site prior to the next inspection.						
Inspector Comment						
Erosion greater than 1' deep and greater than 3' wide. Owner backfilled erosion with rock 3/4 filled. Still need to backfill the remaining erosion.

Looking north at erosion on waterward shoulder and slope.

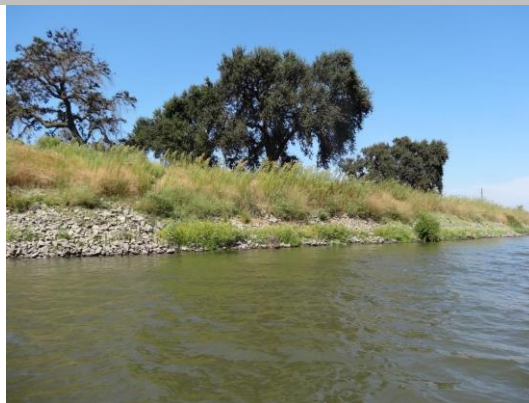
Photo 1 of 2 : SP_2018_RD0544_109_7_20180323_00006.jpg

LM Start	2.68	Rating **	M	Issue No.	7
LM End	2.70	Issue Type +	Ma	Location *	WS
Category	Supplemental			GPS Latitude/Longitude	
				Start	End
Item	DWR Erosion Survey			37.817905 °	37.817905 °
				-121.351102 °	-121.351102 °
DWR ID	RD0544U02RM32.91				
Comment Code					
Inspector Comment					
09/13/2017: No significant change observed.					
07/25/2016: No significant change observed.					
06/25/2015: No significant change observed.					
07/02/2014: No significant change observed.					
10/11/2013: No significant change observed.					
08/07/2012: Series of pocket erosion were discovered at the levee toe during the boat survey. The area is covered with vegetation and riprap, but the rip rap has been washed away. [2017 Site ID:RD0544U02RM32.91]

Front view of the pocket erosion. Note vegetation and riprap at the site.

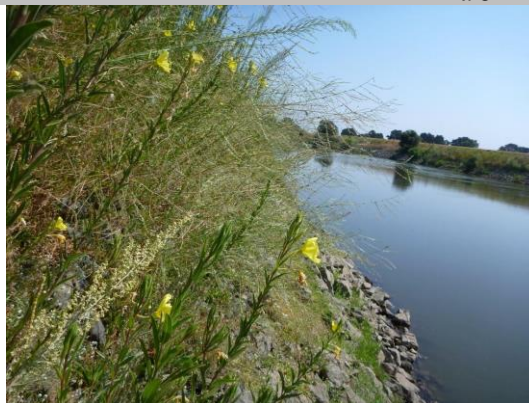
Photo 3 of 3 : LEVAL_SP_2018_548_4669.jpg

LM Start	2.68	Rating **	A/W	Issue No.	90 (cont)
LM End	2.71	Issue Type +	Ma	Location *	
Category	Supplemental			GPS Latitude/Longitude	
				Start	End
Item	2017 Storm Damage			37.818000 °	37.817800 °
				-121.351200 °	-121.351500 °
DWR ID	DWR_RD0544_02_f_2017_90				
Comment Code					
Inspector Comment					
Levee Evaluation Comments					
Description:Slope protection repairs are needed along the waterside slope due to erosion and riprap displacement from high water. Based upon levee inspections, it was determined the waterside levee slope is eroding, deteriorating, and degrading. The eroded levee sections need to be restored back to design standards to prevent further deterioration and damage.					
Site ID No:548					
Site Designation:LMA-454					
Repair Type: Erosion					
Rating:Area of Concern					
Field Date:8/18/2017					
Notes:

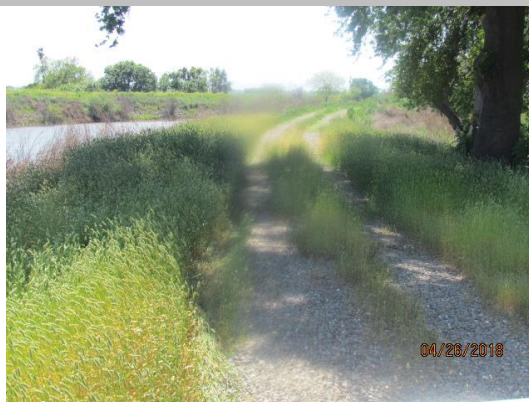
Photo 1 of 3 : SP_2018_RD0544_109_52_20180427_00131.jpg

LM Start	2.69	Rating **	U	Issue No.	52
LM End	3.11	Issue Type +	Ma	Location *	CR
Category	Earthen Levee			GPS Latitude/Longitude	
				Start	End
Item	Vegetation			37.817928 °	37.817698 °
				-121.351355 °	-121.358582 °
DWR ID	DWR_RD0544_02_f_2014_52				
Comment Code					
V9 : Keep the crown roadway free of vegetation.					
Inspector Comment

Looking south at veg on levee crown. (Spring 2018)

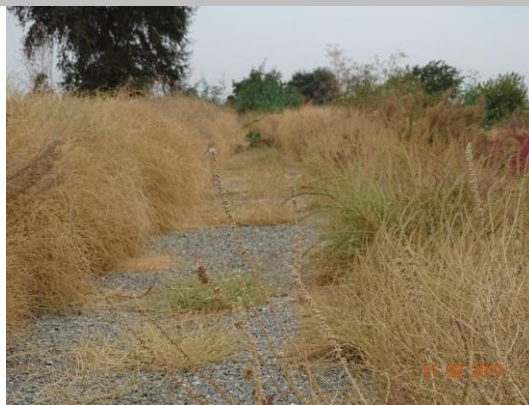
Photo 3 of 3 : SP_2018_RD0544_109_52_20180323_00042.jpg

Looking southwest at levee crown.

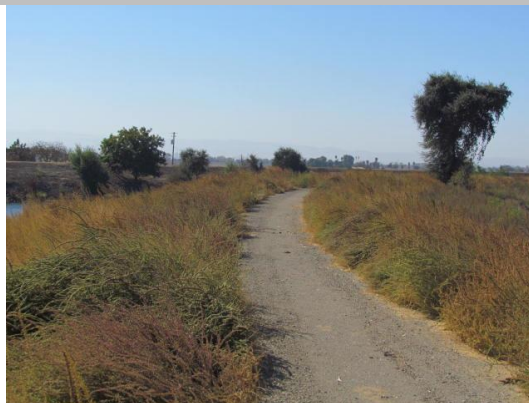
Photo 2 of 2 : SP_2018_RD0544_109_43_20180323_00040.jpg

LM Start	2.71	Rating **	U	Issue No.	43 (cont)	
LM End	3.45	Issue Type +	Ma	Location *	LS	
Category	Earthen Levee			GPS Latitude/Longitude		
				Start		End
Item	Vegetation			37.817747 °		37.819583 °
				-121.351578 °		-121.363559 °
DWR ID	DWR_RD0544_02_s_2012_43					
Comment Code						
V2 : Remove the wild growth other than native grasses from the levee slopes.						
Inspector Comment

Looking at dense vegetation on landward and waterward slope.

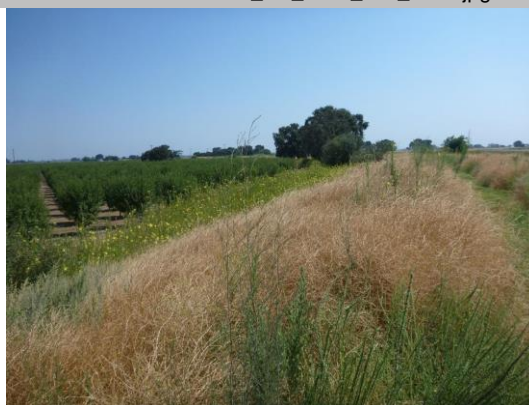
Photo 1 of 3 : LEVAL_SP_2018_547_4677.jpg

Comment Code					
Inspector Comment					
Levee Evaluation Comments					
Description:Slope protection repairs are needed along the waterside slope due to erosion and riprap displacement from high water. Based upon levee inspections, it was determined the waterside levee slope is eroding, deteriorating, and degrading. The eroded levee sections need to be restored back to design standards to prevent further deterioration and damage.					
Site ID No:547					
Site Designation:LMA-453					
Repair Type: Erosion					
Rating:Area of Concern					
Field Date:8/18/2017					
Notes: levee slopes covered in dense vegetations that hindered visibility.

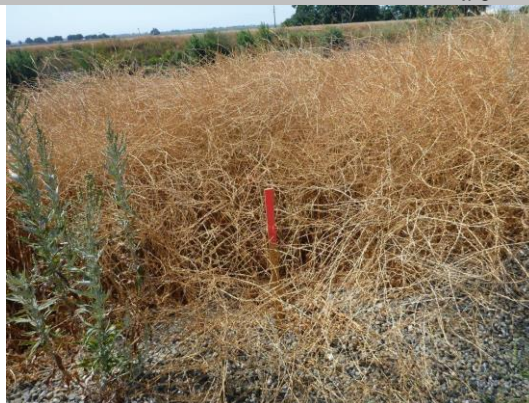
Photo 2 of 3 : LEVAL_SP_2018_547_4687.jpg

Comment Code						
Inspector Comment						
Levee Evaluation Comments						
Description:Slope protection repairs are needed along the waterside slope due to erosion and riprap displacement from high water. Based upon levee inspections, it was determined the waterside levee slope is eroding, deteriorating, and degrading. The eroded levee sections need to be restored back to design standards to prevent further deterioration and damage.						
Site ID No:547						
Site Designation:LMA-453						
Repair Type: Erosion						
Rating:Area of Concern						
Field Date:8/18/2017						
Notes: levee slopes covered in dense vegetations that hindered visibility.

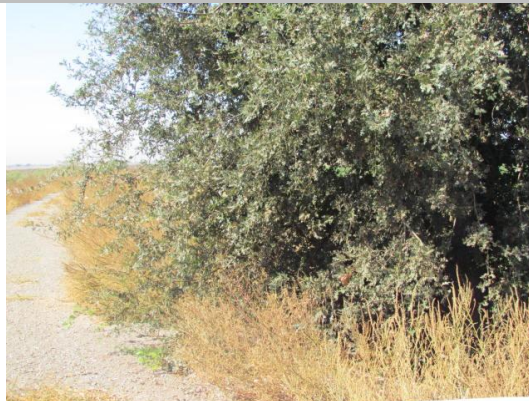
Photo 1 of 1 : SP_2018_RD0544_109_53_20180323_00044.jpg

LM Start	2.80	Rating **	A/W	Issue No.	53
LM End	2.80	Issue Type +	Ma	Location *	LS
Category	Earthen Levee			GPS Latitude/Longitude	
				Start	End
Item	Trim / Thin Trees			37.817187 °	37.817187 °
				-121.352964 °	-121.352964 °
DWR ID	DWR_RD0544_02_f_2014_53				
Comment Code					
T2 : Thin trees to allow visibility of the ground and room to flood fight.					
Inspector Comment

Looking southwest at untrimmed tree on landward slope fall 2015.

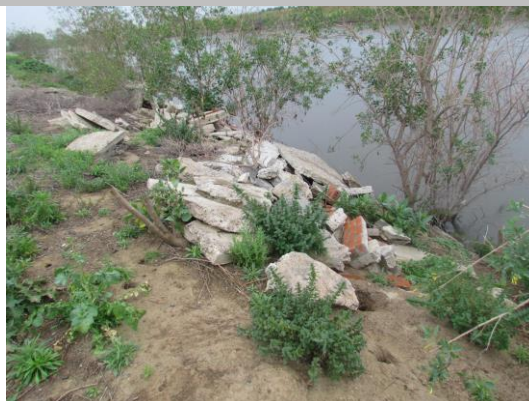
Photo 1 of 1 : SP_2018_RD0544_109_77_20180323_00062.jpg

LM Start	3.10	Rating **	U	Issue No.	77
LM End	3.10	Issue Type +	Ma	Location *	WS
Category	Earthen Levee			GPS Latitude/Longitude	
				Start	End
Item	Erosion / Bank Caving			37.817588 °	37.817588 °
				-121.358352 °	-121.358352 °
DWR ID	DWR_RD0544_02_s_2017_77				
Comment Code					
E1 : Note and monitor erosion site.					
Inspector Comment					
Rip rap was placed but does not meet Title 23 standards.

Looking northeast at concrete rubble on waterward slope.

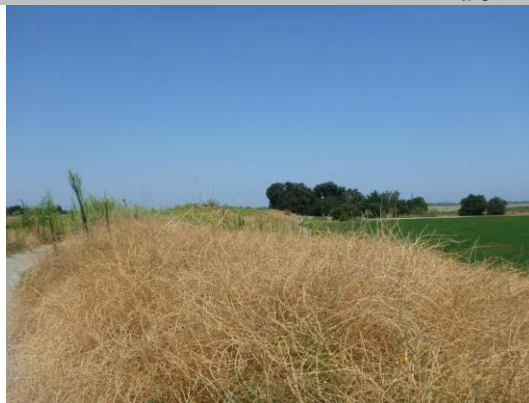
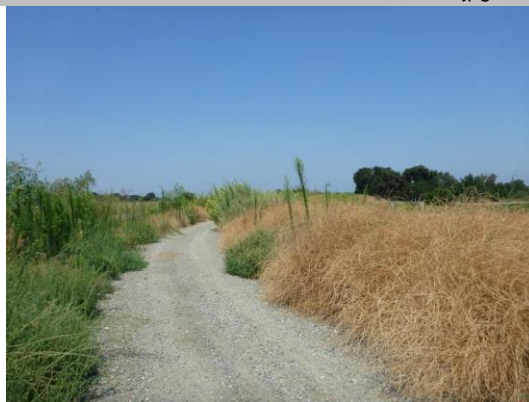
Comment Code					
Inspector Comment					
Levee Evaluation Comments					
Description:Slope protection repairs are needed along the waterside slope due to erosion and riprap displacement from high water. Based upon levee inspections, it was determined the waterside levee slope is eroding, deteriorating, and degrading. The eroded levee sections need to be restored back to design standards to prevent further deterioration and damage.					
Site ID No:546					
Site Designation:LMA-452					
Repair Type: Erosion					
Rating:Area of Concern					
Field Date:8/18/2017					
Notes: dense vegetations on both sides of the levee made the slopes inaccessible

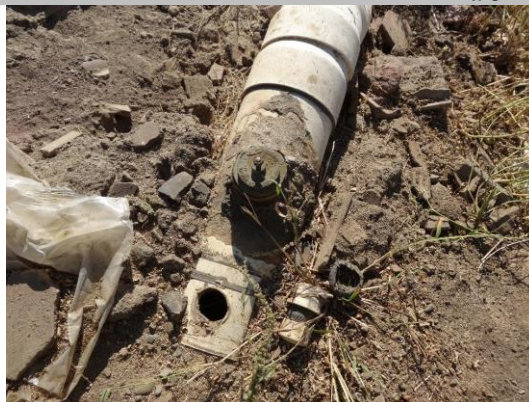
Photo 2 of 3 : UCIP_SP_2018_24908_44897.jpg

WS view: 8" white pvc pipe with siphon breaker on levee shoulder. An unplugged hole on the pipe.

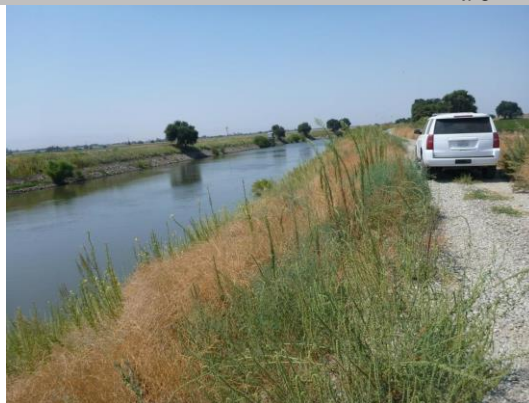
Photo 2 of 3 : LEVAL_SP_2018_545_4712.jpg

LM Start	3.25	Rating **	A/W	Issue No.	93 (cont)
LM End	3.34	Issue Type +	Ma	Location *	
Category	Supplemental			GPS Latitude/Longitude	
				Start	End
Item	2017 Storm Damage			37.819300 °	37.819800 °
				-121.360200 °	-121.361600 °
DWR ID	DWR_RD0544_02_f_2017_93				
Comment Code					
Inspector Comment					
Levee Evaluation Comments					
Description:Slope protection repairs are needed along the waterside slope due to erosion and riprap displacement from high water. Based upon levee inspections, it was determined the waterside levee slope is eroding, deteriorating, and degrading. The eroded levee sections need to be restored back to design standards to prevent further deterioration and damage.					
Site ID No:545					
Site Designation:LMA-451					
Repair Type: Erosion					
Rating:Area of Concern					
Field Date:8/18/2017					
Notes:

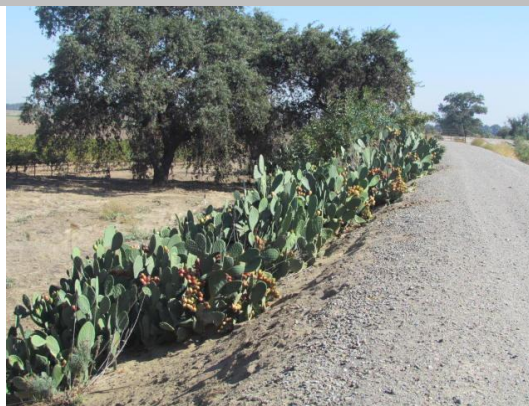
Photo 1 of 3 : SP_2018_RD0544_109_36_20180323_00030.jpg

LM Start	3.48	Rating **	A/W	Issue No.	36
LM End	3.51	Issue Type +	Ma	Location *	LS
Category	Earthen Levee			GPS Latitude/Longitude	
				Start	End
Item	Vegetation			37.819576 °	37.819530 °
				-121.364056 °	-121.364653 °
DWR ID	DWR_RD0544_02_s_2012_36				
Comment Code					
V2 : Remove the wild growth other than native grasses from the levee slopes.					
Inspector Comment					
Cactus on landside slope.

Looking northwest at cactus on landward slope and toe fall 2015

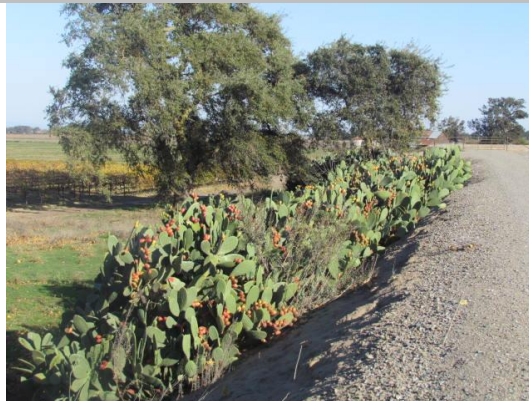
Photo 2 of 3 : SP_2018_RD0544_109_36_20180323_00031.jpg

Looking north at cactus on landside slope and toe spring 2015

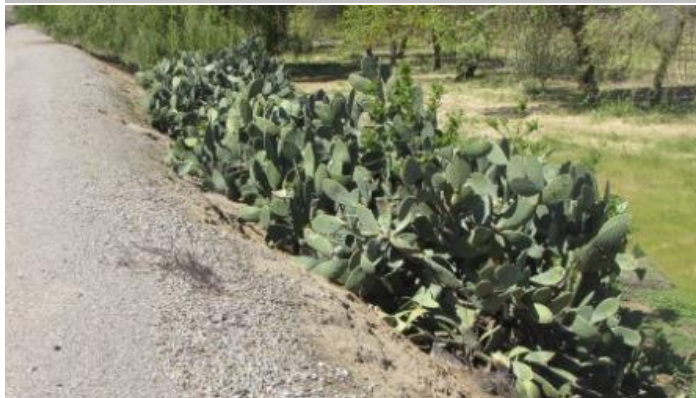
Photo 3 of 3 : SP_2018_RD0544_109_36_20180323_00032.jpg

LM Start	3.48	Rating **	A/W	Issue No.	36 (cont)	
LM End	3.51	Issue Type +	Ma	Location *	LS	
Category	Earthen Levee			GPS Latitude/Longitude		
				Start		End
Item	Vegetation			37.819576 °		37.819530 °
				-121.364056 °		-121.364653 °
DWR ID	DWR_RD0544_02_s_2012_36					
Comment Code						
V2 : Remove the wild growth other than native grasses from the levee slopes.						
Inspector Comment						
Cactus on landside slope.

Looking southwest at overgrown cactus on landside slope spring 2015.

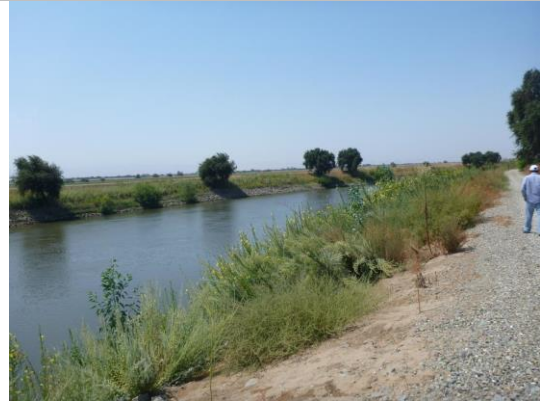
Photo 3 of 3 : LEVAL_SP_2018_544_4783.jpg

LM Start	3.51	Rating **	A/W	Issue No.	94 (cont)
LM End	3.55	Issue Type +	Ma	Location *	
Category	Supplemental			GPS Latitude/Longitude	
				Start	End
Item	2017 Storm Damage			37.819500 °	37.819400 °
				-121.364700 °	-121.365400 °
DWR ID	DWR_RD0544_02_f_2017_94				
Comment Code					
Inspector Comment					
Levee Evaluation Comments					
Description:Slope protection repairs are needed along the waterside slope due to erosion and riprap displacement from high water. Based upon levee inspections, it was determined the waterside levee slope is eroding, deteriorating, and degrading. The eroded levee sections need to be restored back to design standards to prevent further deterioration and damage.					
Site ID No:544					
Site Designation:LMA-450					
Repair Type: Erosion					
Rating:Area of Concern					
Field Date:8/18/2017					
Notes:

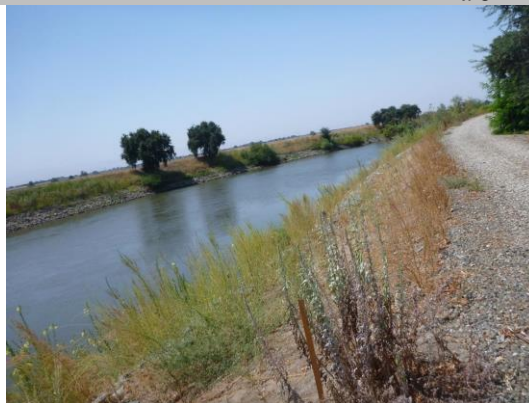
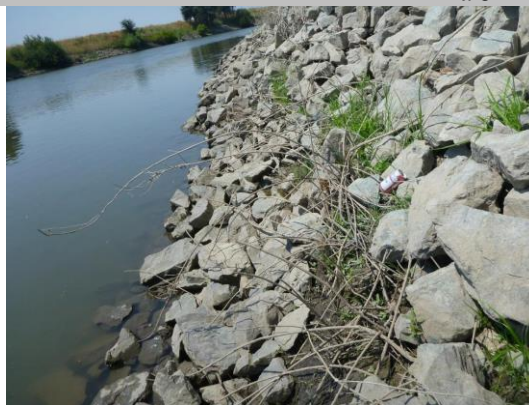
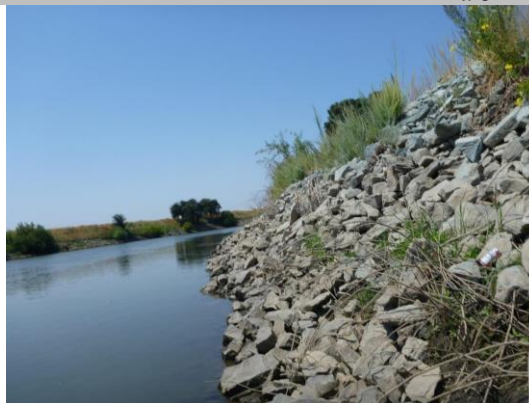
LM Start	3.57	Rating **	A/W	Issue No.	95
LM End	3.58	Issue Type +	Ma	Location *	
Category	Supplemental			GPS Latitude/Longitude	
				Start	End
Item	2017 Storm Damage			37.819400 °	37.819400 °
				-121.365800 °	-121.365900 °
DWR ID	DWR_RD0544_02_f_2017_95				
Comment Code					
Inspector Comment					
<p>Levee Evaluation Comments</p> <p>Description: Slope protection repairs are needed along the waterside slope due to erosion and riprap displacement from high water. Based upon levee inspections, it was determined the waterside levee slope is eroding, deteriorating, and degrading. The eroded levee sections need to be restored back to design standards to prevent further deterioration and damage.</p> <p>Site ID No: 543</p> <p>Site Designation: LMA-449</p> <p>Repair Type: Erosion</p> <p>Rating: Area of Concern</p> <p>Field Date: 8/18/2017</p> <p>Notes:</p>

LM Start	3.57	Rating **	A/W	Issue No.	95 (cont)
LM End	3.58	Issue Type +	Ma	Location *	
Category	Supplemental			GPS Latitude/Longitude	
				Start	End
Item	2017 Storm Damage			37.819400 °	37.819400 °
				-121.365800 °	-121.365900 °
DWR ID	DWR_RD0544_02_f_2017_95				
Comment Code					
Inspector Comment					
Levee Evaluation Comments					
Description:Slope protection repairs are needed along the waterside slope due to erosion and riprap displacement from high water. Based upon levee inspections, it was determined the waterside levee slope is eroding, deteriorating, and degrading. The eroded levee sections need to be restored back to design standards to prevent further deterioration and damage.					
Site ID No:543					
Site Designation:LMA-449					
Repair Type: Erosion					
Rating:Area of Concern					
Field Date:8/18/2017					
Notes:
